Manhole Inspection Summary

Manhole # S05AA2025MH

Insp Date: **9/20/06 3:04 PM**

Location Address: **6018 CROSS COUNTRY BLVD** Cross Street: **PARKINGTON AVE**

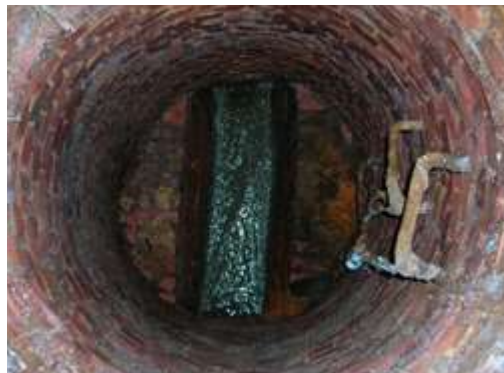
Top View

Evidence of surcharge - Bench debris.
Corroded steps.

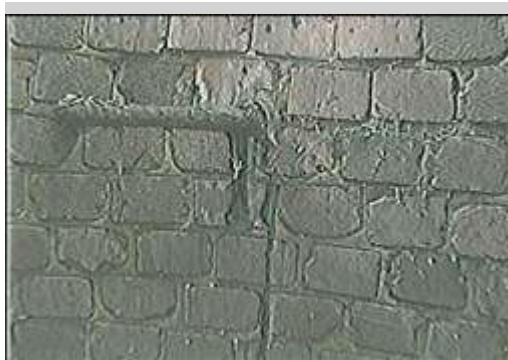
Evidence of surcharge

Surcharge ☒ **Evidence Of Surcharge** Depth: **5** (ft.) ☐ Active Surcharge Present

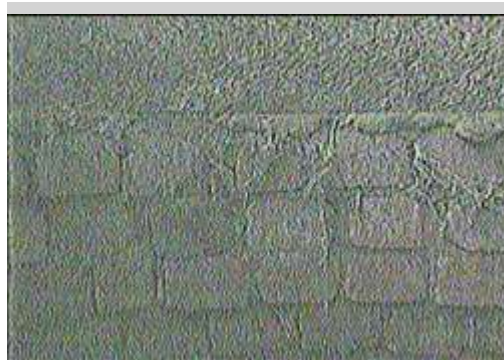
Defect

Chimney / Frame Adjustment ☒ Exists Material: **Brick** ☐ Parged Height: **11** (in.)
Condition: ☐ Sound ☐ Cracked ☒ **Root Intrusion** ☐ Loose Brick ☐ Deteriorated
Infiltration: ☐ None ☒ **Joint** ☐ Cracks ☒ **Mortar** ☒ **Roots** ☐ Wall

Adjustment root intrusion and infiltration.

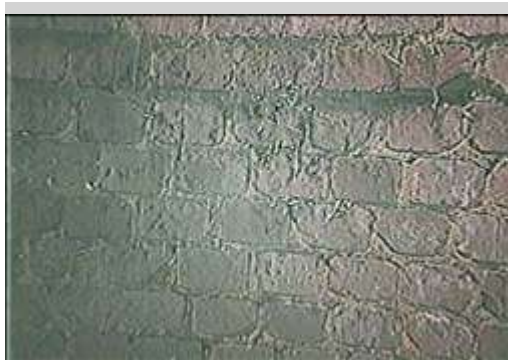
Defect

Barrel Material: **Brick** ☐ Parged
Shape: **Circular** Diameter: **48** (in.) Length: (in.)
Condition: ☐ Sound ☐ Cracked ☒ **Root Intrusion** ☐ Loose Brick ☒ **Deteriorated**
Infiltration: ☐ None ☐ Joint ☐ Cracks ☒ **Mortar** ☒ **Roots** ☒ **Wall**

Barrel deterioration, root intrusion and infiltration.

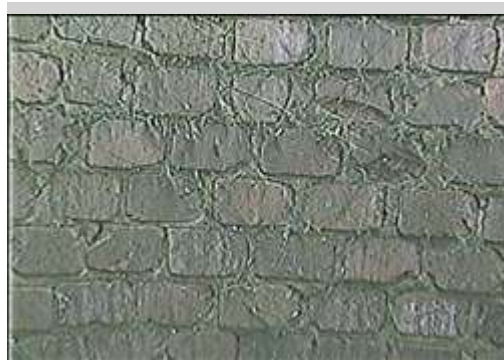
Defect

Corbel Material: **Brick** ☐ Parged Type: **Concentric/Eccentric**
Condition: ☐ Sound ☐ Cracked ☒ **Root Intrusion** ☐ Loose Brick ☐ Deteriorated
Infiltration: ☐ None ☐ Joint ☐ Cracks ☒ **Mortar** ☒ **Roots** ☒ **Wall**

Corbel root intrusion and infiltration.

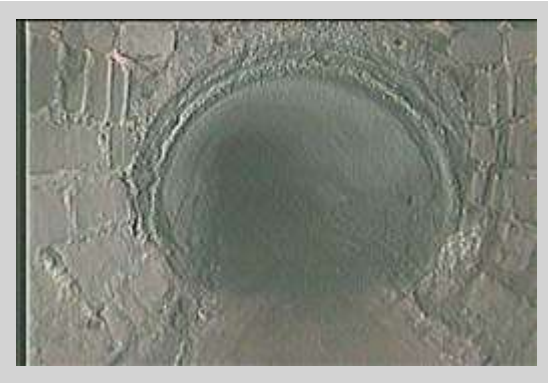
21 in. Circular Gravity Sewer Pipe Out @ 12 O'Clock

Channel deterioration.

Infiltration: **Evidence** Pipe Seal Cond: **Unknown**

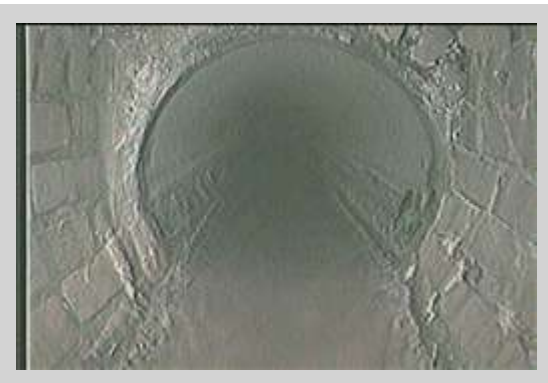
21 in. Circular Gravity Sewer Pipe In @ 6 O'Clock

Infiltration: **Evidence** Pipe Seal Cond: **Cracked**
